Minerals Inspection Report

Report Date: 04/09/2015

| Mine Name: Eureka Rock | Permit Number: S/023/0094 | Mine Status: Active |
| Inspection Purpose: Routine inspection | | Prior Inspection: 10/17/2013 |

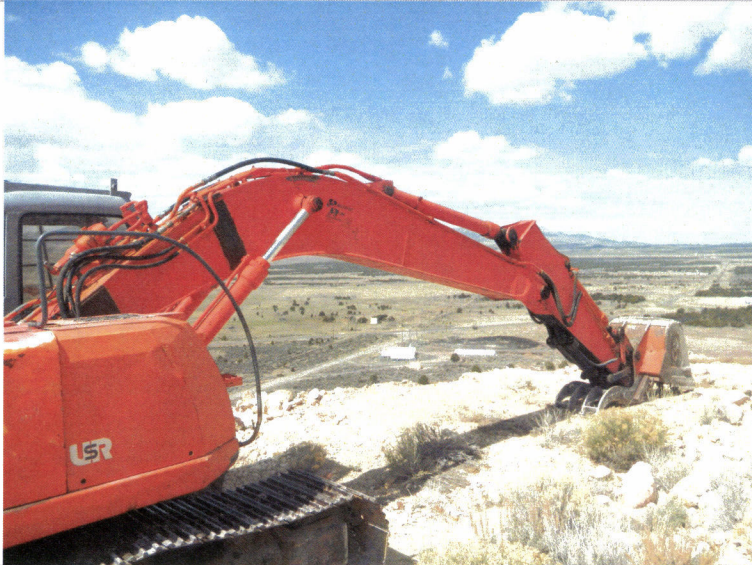
Excavator on site.

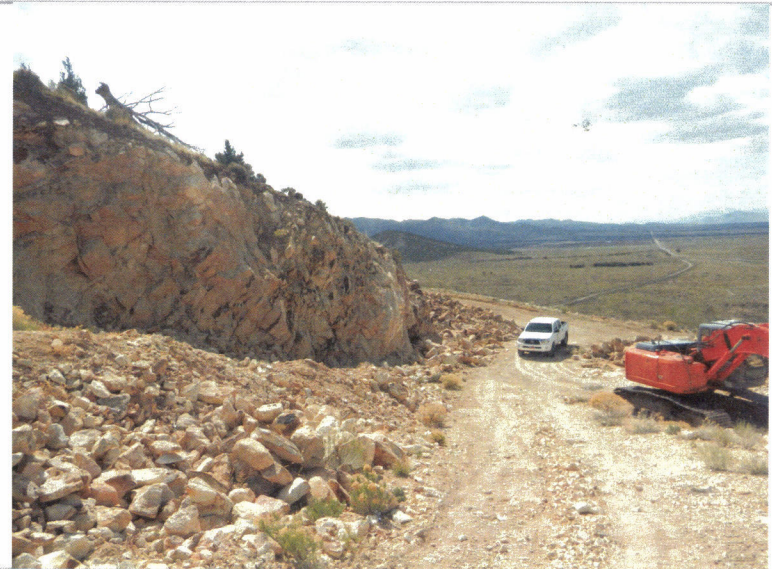
| Elements of Inspection | Evaluated & Commented | Enforcement |
|---|---|---|
| 2. Public Safety (shafts, adits, trash, signs, highwalls) The highwalls appear to be stable. | <input checked="" type="checkbox"/> | <input type="checkbox"/> |

Looking south highwall on left.

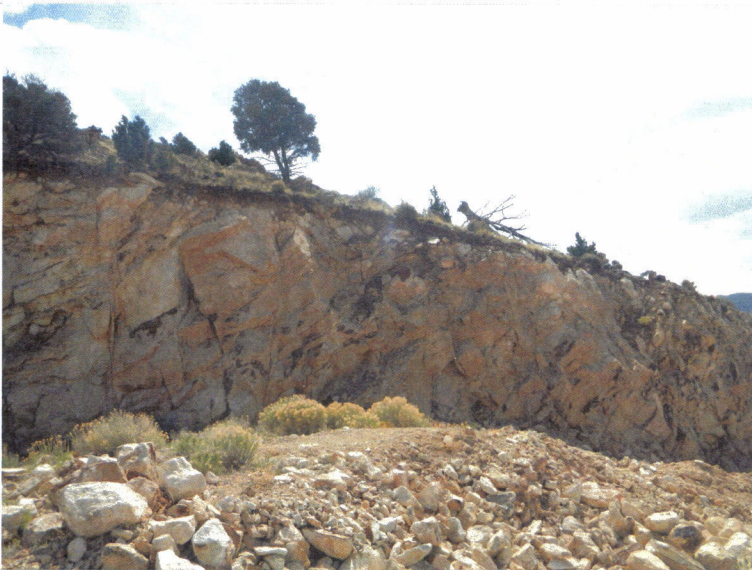
Looking east at the highwall

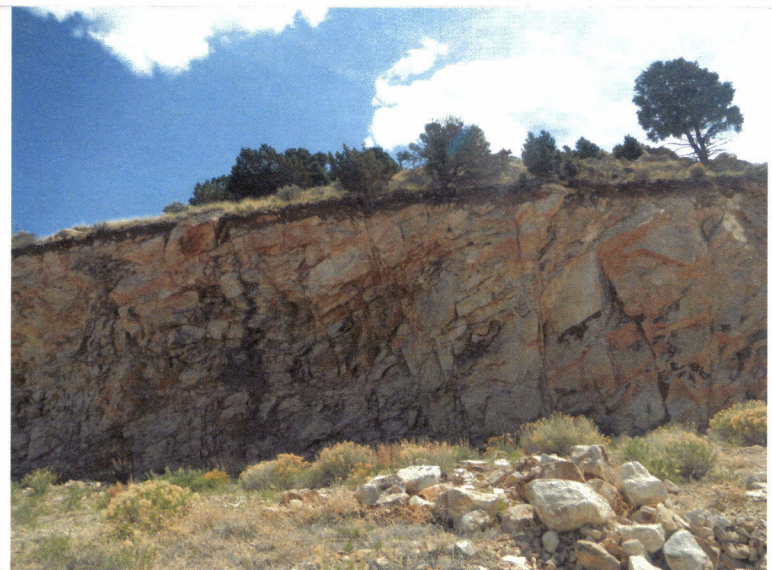
Looking east at the highwall - notice the vegetation in the foreground.
